## Lean On Me...Radiant Walls

Our current renovation project, within a year of being completed - has over the years been featured in a number of publications including the Hydronics Marketing Groups promotional literature

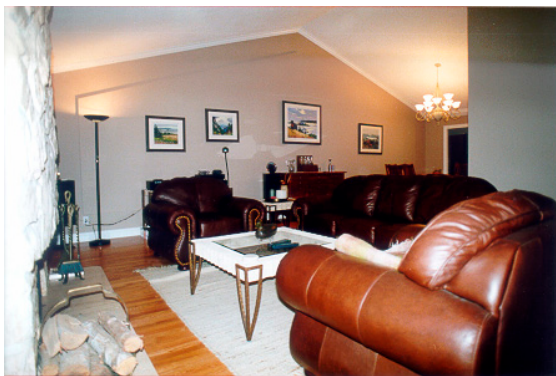
Phase 2 in 1995 was a complete renovation of the kitchen, dining, and living room. The space now gets its primary heat from a radiant wall profiled on top of an existing exterior wall with one of the new fan/coils dedicated more appropriately to humidification, filtration, make up air and secondary heat.

Why a radiant wall? Our objective for the space was to create an environment, which was thermally stable with constant humidity for the woodwork including floors, guitars, antique decoys and the other furnishings. Although the room has a vaulted ceiling, we chose not to lose any height and access to the basement ceiling was not scheduled until this year so a heated vertical surface was a natural choice.

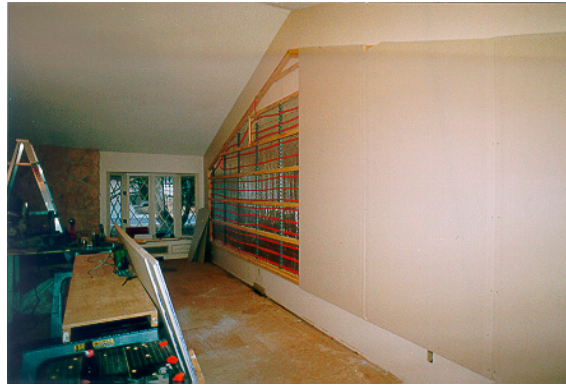
The design of a radiant wall is almost identical to any other type of site built radiant surface addressing such issues as fluid and surface temperatures, back losses, and venting. Whereas floors have a higher heat transfer coefficient for heating, ceilings a better coefficient for cooling, radiant walls are neutral in heating and cooling

performance simply because of the convection influence on radiant

surfaces. Walls are not as restricted by tube spacing or lower surface temperatures, as such can use higher fluid temperatures to deliver greater Btu/sf. Having higher output surfaces allows mechanical and interior designers greater flexibility in specifying physical dimensions and location.

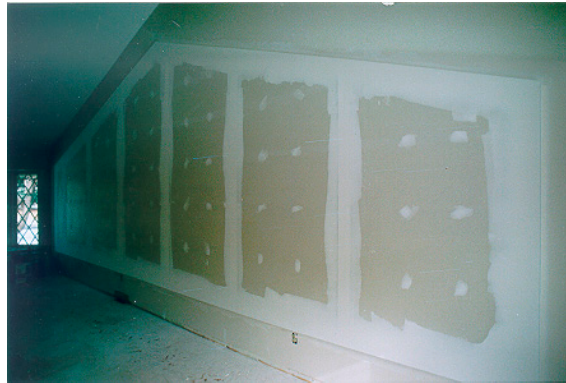
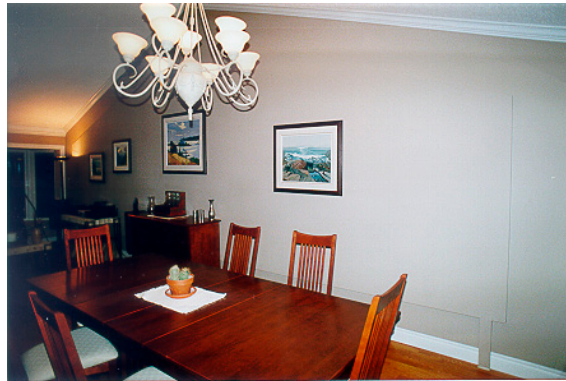
Wall installations, like most other radiant systems can be correctly fabricated in a number of different ways. For our system, the radiant surface was framed out to match the profile of the wall. Once the strapping was mounted to the studs, reflective insulation was fastened to the back surface followed by the installation of plastic pipe tracking which profile provided an air space between the foil backed insulation and finished drywall. A single ½" loop of PEX was then routed to and from the prefabricated zone control panel located in the boiler room through the tracking system. A manual air vent was piped vertically from highest point on the loop and is hidden out of site at the pinnacle of the profile. Following the first pressure test the wall was then boarded, taped, and finished.

Prior to painting, a second pressure test confirmed no damaged had occurred during the drywalling stage. Once the surface was completed the system was commissioned, and room stabilized at 68°F and 40% RH. At this point, the hardwood flooring was brought in for a week of acclimation and then installed. The final concern was possible damage to the PEX tubing when the paintings were hung and potential harm to the artwork from the heated surface. To address panel damage the wall was blueprinted and photographed prior to boarding. All dimensions and details recorded in the Operation and Maintenance
